**Summary of *Expedition 'Operation Dukedom'* which carried  
Explorers Club Flag #52 while surveying the wreck of  
*HIJMS Haguro*,  
Malacca Strait  
November 8<sup>th</sup> - November 23<sup>rd</sup>, 2010**

This report written and submitted by expedition member and E.C. Flag applicant  
Kevin Denlay, Fellow International 1998.

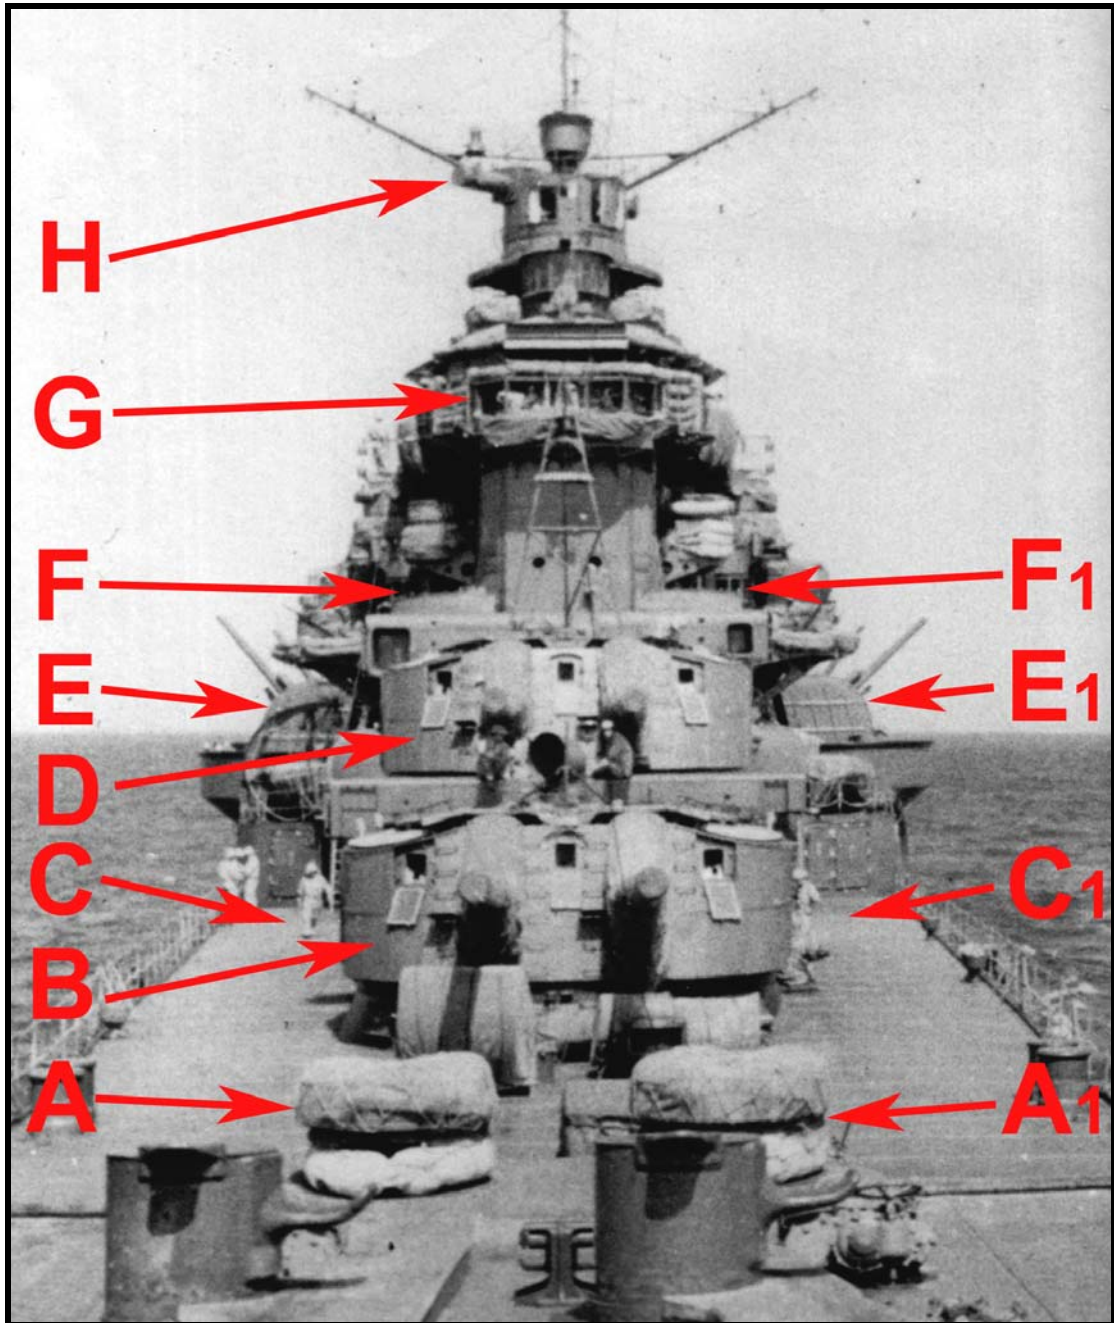
## Reference Photo 1

*Haguro's foredeck and bridge superstructure. A historical photo taken from the bow looking towards the bridge superstructure, circa 1941. A through H are the 'objects' referenced or illustrated (i.e. underwater - u/w - photos) in the adjacent pages: A, A1) Starboard and port anchor capstans (covered), referenced page 17; B) #1 eight-inch turret, u/w photo page 19 and referenced page 18; C, C1) Note the absence - on the starboard and port deck just forward of the bridge - of the two triple 25mm AA guns which had not yet been installed, u/w photos and referenced page 20; D) #2 eight-inch turret, referenced pages 17,18,19; E, E1) Starboard and port (forward) five-inch dual HA guns, referenced pages 22,23; F, F1) Starboard and port open bridge wings, referenced page 22; G) Rectangular upper bridge windows, referenced page 20; H) 6m/20ft main (gun) rangefinder, referenced page 20.*

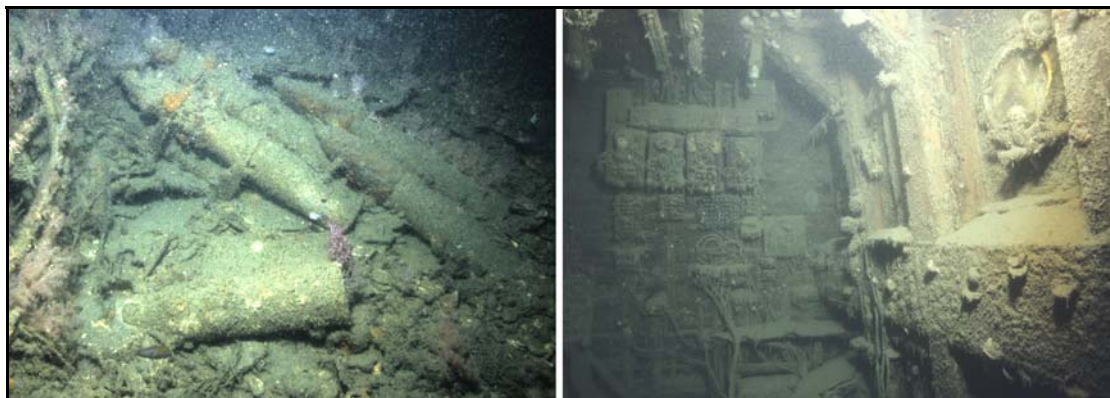
***Right.** Inside the Cipher Room at the rear of the Lower Bridge Level. **Left.** Live 5" ammunition lies scattered about on the starboard deck just abaft the superstructure.*

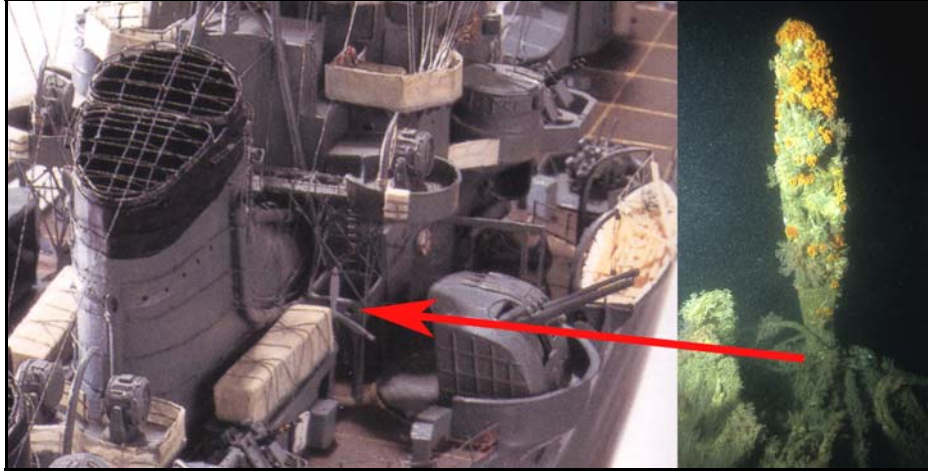
*An intact three bladed (spare) aircraft propeller can be found inboard of the forward starboard five inch mount (as shown on the scale model left). Photo at right shows the upright coral encrusted blade.*

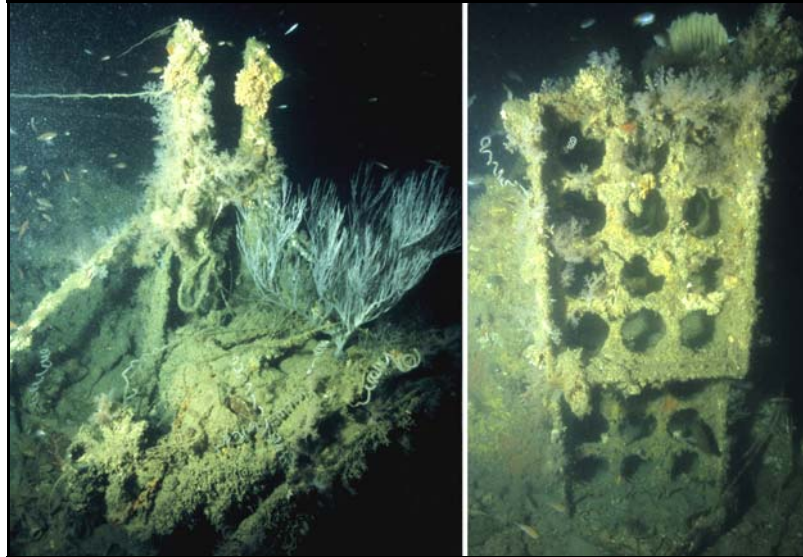
Quite noticeable on the deck on the port side, between the forward and aft five-inch HA mounts, obviously situated for 'easy access', are several completely empty cabinet-style five-inch ready ammunition racks looking for all the world like outsized wine-bottle cabinets with their empty circular storage holes (*below right*). Inboard of

one of these 'cabinets' is a pile of coral incrustated live five-inch shells that appear to have been stockpiled in a separate main storage area. On the opposite side of the ship, i.e. to starboard, in the area between the forward and aft starboard five-inch HA mounts is a twin 25mm AA weapon collapsed down onto the Upper Deck (*below left*).

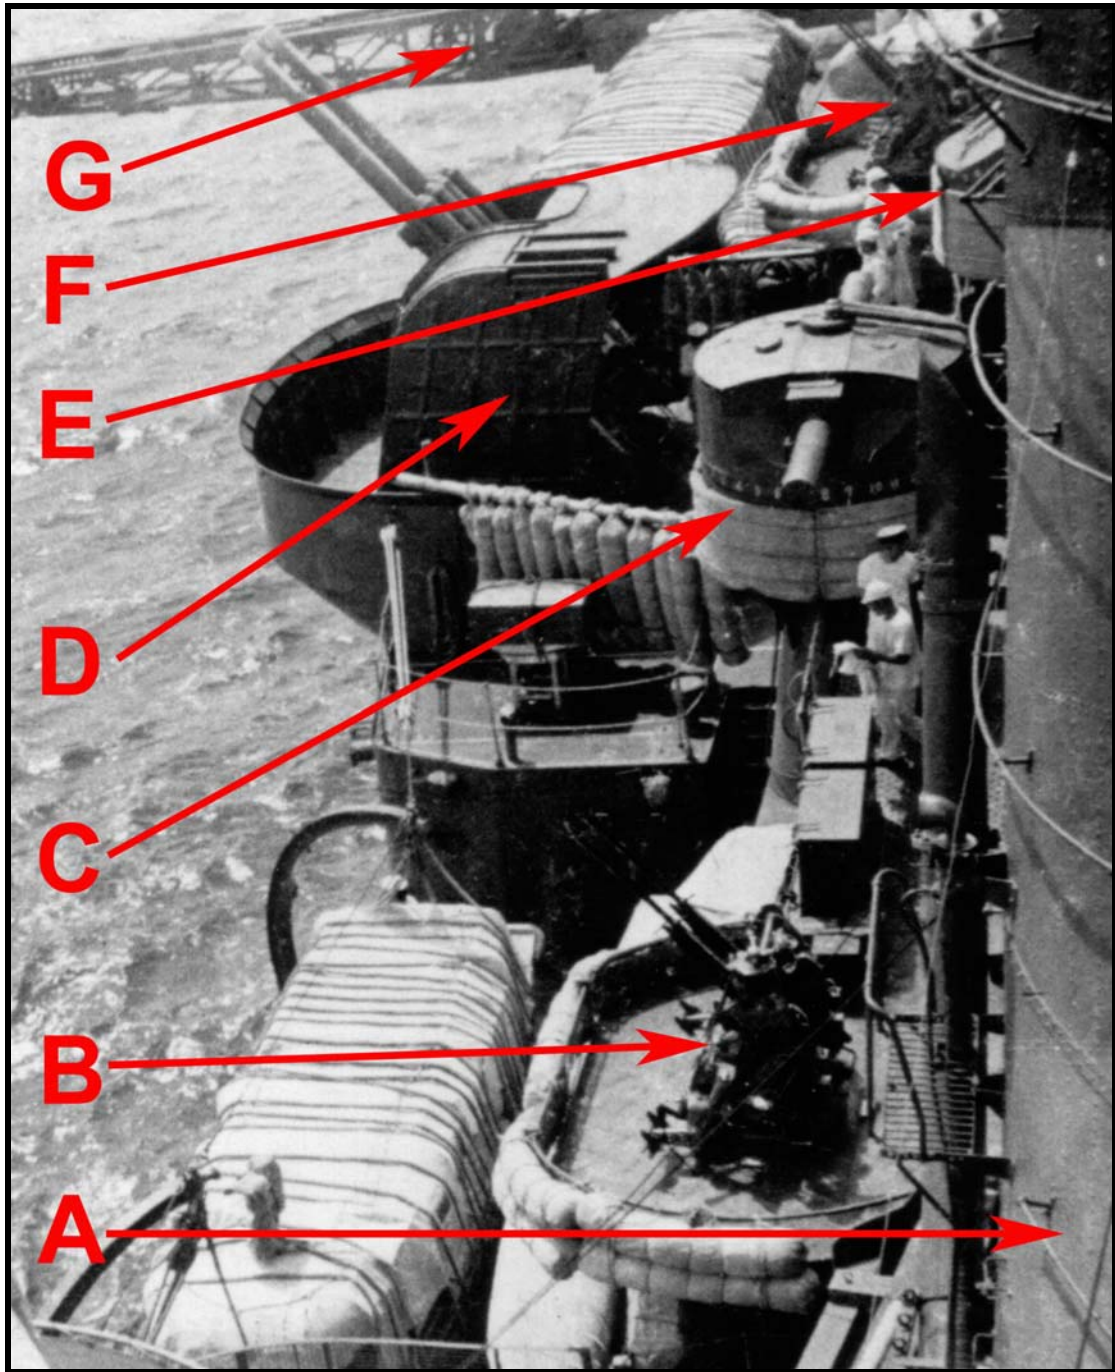
## Reference Photo 2

*Haguro's starboard side amidships. A historical photo taken from the rear of the upper bridge looking down amidships on the starboard side, circa 1941. A through G are the 'objects' referenced or illustrated (i.e. underwater - u/w - photos) in the adjacent pages: A) Fore funnel, referenced page 22; B) 25mm dual AA gun, u/w photo and referenced page 24; C) Type 91 4.5m/15ft rangefinder (for the five-inch HA guns), referenced page 24; D) Rear five-inch dual HA gun. u/w photo page 24 and referenced pages 24,25; E) Type 95 director (for the 25mm AA guns), referenced page 24; F) 25mm dual AA gun, u/w photo page 25 and referenced pages 24,25; G) Aircraft catapult launching track (swivelled outboard), referenced pages 27,28.*

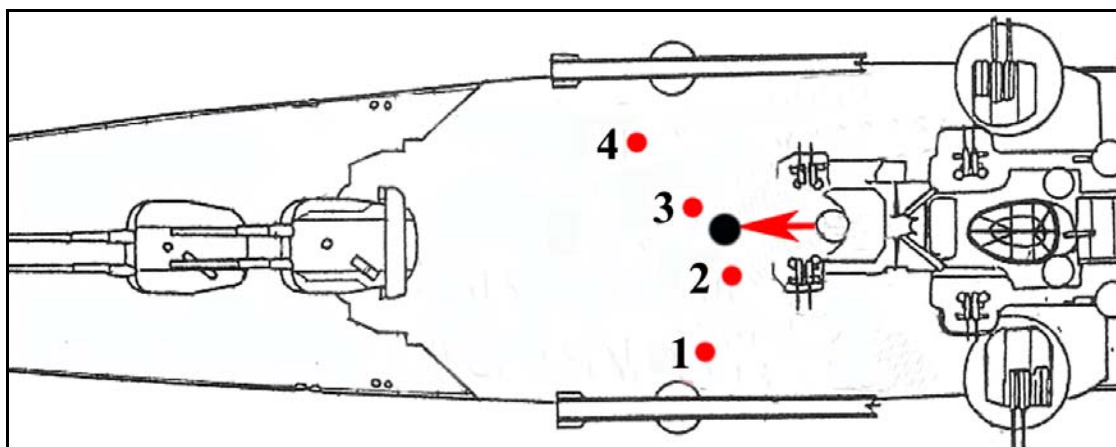
Just outboard and abaft either side of the collapsed auxiliary director itself are two sets of *triple* 25mm AA guns (one laying over on its side - #2 red dot below; and one upright - #3 red dot below), which apparently had been situated at the same level as the director itself and have hence collapsed down with it. Further outboard and abaft these two triples, that is just inboard of the port and starboard catapult rotation points, are another two sets of *triple* 25mm AA guns (one upright - #1 red dot below; and one laying over on its side - #4 red dot below). [Note; *none* of these four triple 25mm AA guns are shown on any late war plans/schematics of *Haguro*.] All four triples (and the director) now lay on the Upper Deck, the Aircraft Handling Deck above having completely collapsed/disintegrated since the sinking. [Given the fires reported raging throughout this area just prior to sinking, that is not surprising]. However, the two triple 25mm's that are now found just inboard of the catapult rotation bases must have originally been mounted on that higher Aircraft Handling Deck, as where they now lie (on the Upper Deck) would have once been a covered area on the ship. Liberally spread around near these weapons are stacks and stacks of 25mm reload magazines.

Shown are the positions of the now collapsed director (black dot; having collapsed aftward in the direction of the red arrow from where it originally stood), and the positions of the four triple 25mm AA guns found in that general area (red dots). The numbers correspond to the photos on the next page. It is assumed that triples #2 and #3 collapsed aft with the director structure; having replaced the two twin 25mm's shown on the schematic outboard the director at some stage post 1944 refit.

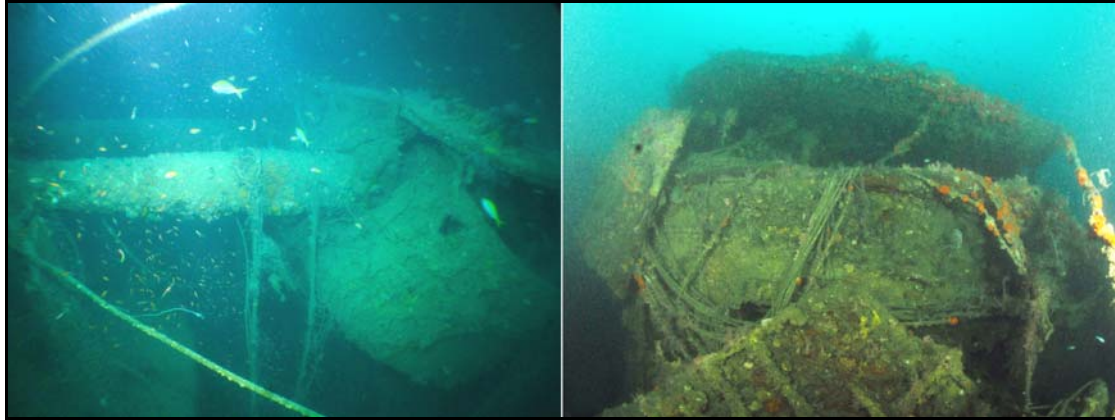
Both rear eight-inch turrets are in place as it were, with the top of the raised #4 eight-inch turret now the highest point aft of the net enshrouded 25mm AA director stand amidships referred to previously (*page 24*). However, the entire rear-wall of the #4 turret has collapsed away (*above right*), and the sidewalls have also partially collapsed (*above left*), completely separating them from the roof of the turret, leaving the turrets innards exposed and the eight-inch gun breaches visible. [*The barrels of the guns in #4 eight-inch turret point directly astern, that is to the 6 o'clock position - and their elevation is, basically, just above level.*]

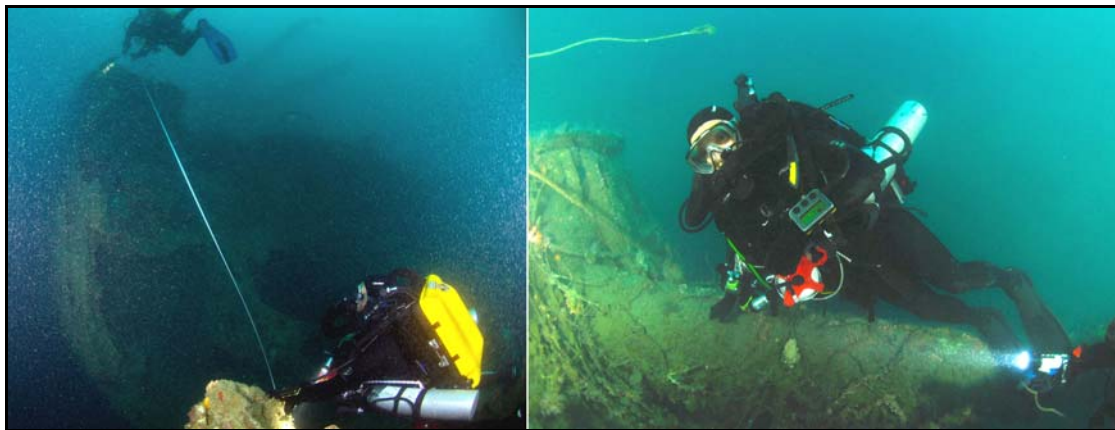
Continuing on, immediately aft of the #5 turret, the Upper Deck itself starts to 'angle down' towards a *break that runs right across the Quarterdeck*. However, the decks edges (where the deck meets the hull) remain relatively 'level' as it were, giving the impression that the edges are 'bent up' on either side of the ship. What has happened however is that most of the deck itself has collapsed almost 2m/6ft downwards 'into' the break, leaving the deck edges themselves forward of the break now slightly higher (at the deck/hull edge) than the rest of the deck *across* the wreck.

**Right.** A survey diver, measuring tape in hand, swims across the starboard barrel of #5 eight inch turret on route to his survey point. The cylinder seen slung at the CCR diver's side (here and in all this reports photos) is open circuit 'bail out' - or emergency - breathing gas, carried simply for safety in the event the CCR should fail.

**Left.** Divers take survey measurements on the port side of the break across the Quarterdeck. The barrels of #5 eight inch turret can be seen at the top just right of the diver while the Main Deck level can also just be made out midway between the divers.

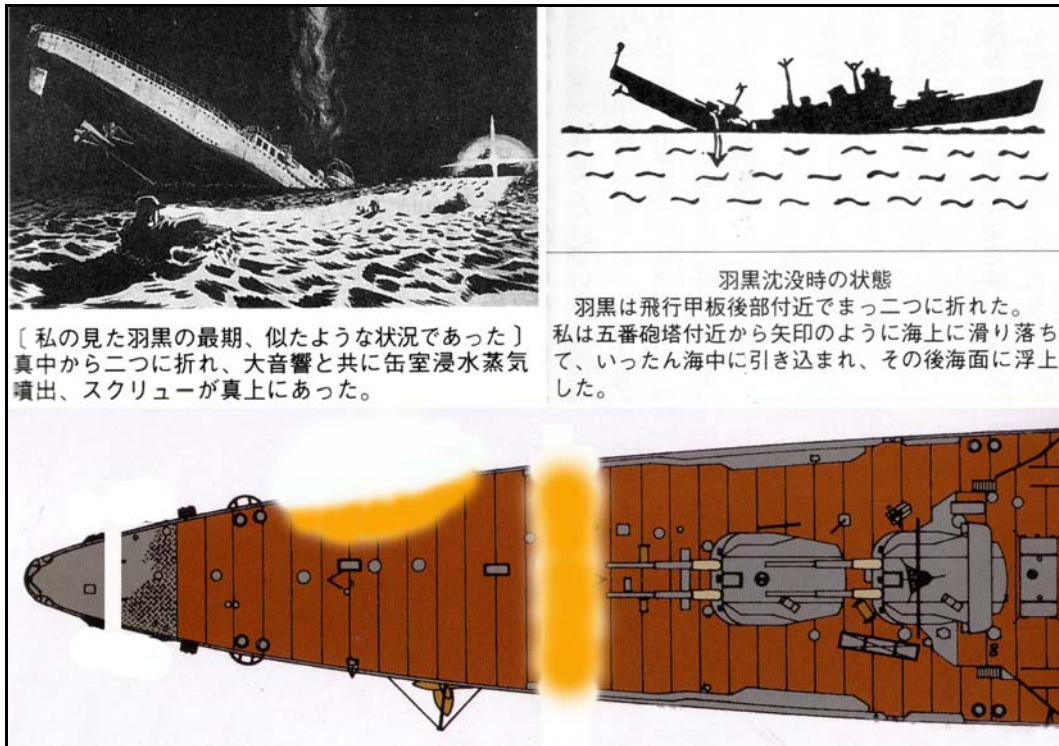
〔私が見た羽黒の最期、似たような状況であった〕  
真中から二つに折れ、大音響と共に缶室浸水蒸気噴出、スクリューが真上にあった。

羽黒沈没時の状態  
羽黒は飛行甲板後部付近でまっ二つに折れた。  
私は五番砲塔付近から矢印のように海上に滑り落ちて、いったん海中に引き込まれ、その後海面に浮上した。

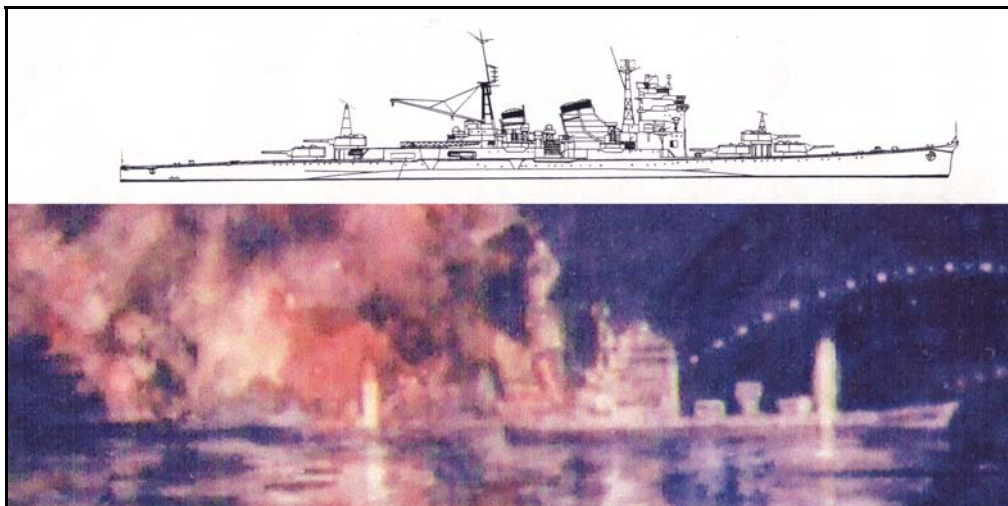
Various British destroyers reported other torpedo hits during the engagement, but in any account the author of this report has seen it is not stated, save for the port bow hit/s, exactly where they impacted. [As stated, the British report at least eight hits in total.] However, reproduced above is a painting that Commander De Chair - in charge

of HMS *Venus* which delivered the last two torpedoes to hit *Haguro* - made post-war and depicts where his torpedoes hit. However, while the forward hit (to starboard) is painfully obvious on the wreck, the one he shows hitting towards the stern is not. That is, although the ship is broken in half across the Quarterdeck just aft of the #5 eight-inch turret, the damage on the starboard side does not look at all like it was caused by a torpedo impact, as it is a very clean 'V' shape, and no torpedo holes were found forward of there. Further aft on the starboard hull there is no 'hole' per se, although there are some hull plates hanging down abaft the outer and inner propellers and, as stated previously, the very stern itself is sheered off. [Could this damage have been caused then by one of the last torpedoes having just 'clipped' *Haguro's* very stern?)

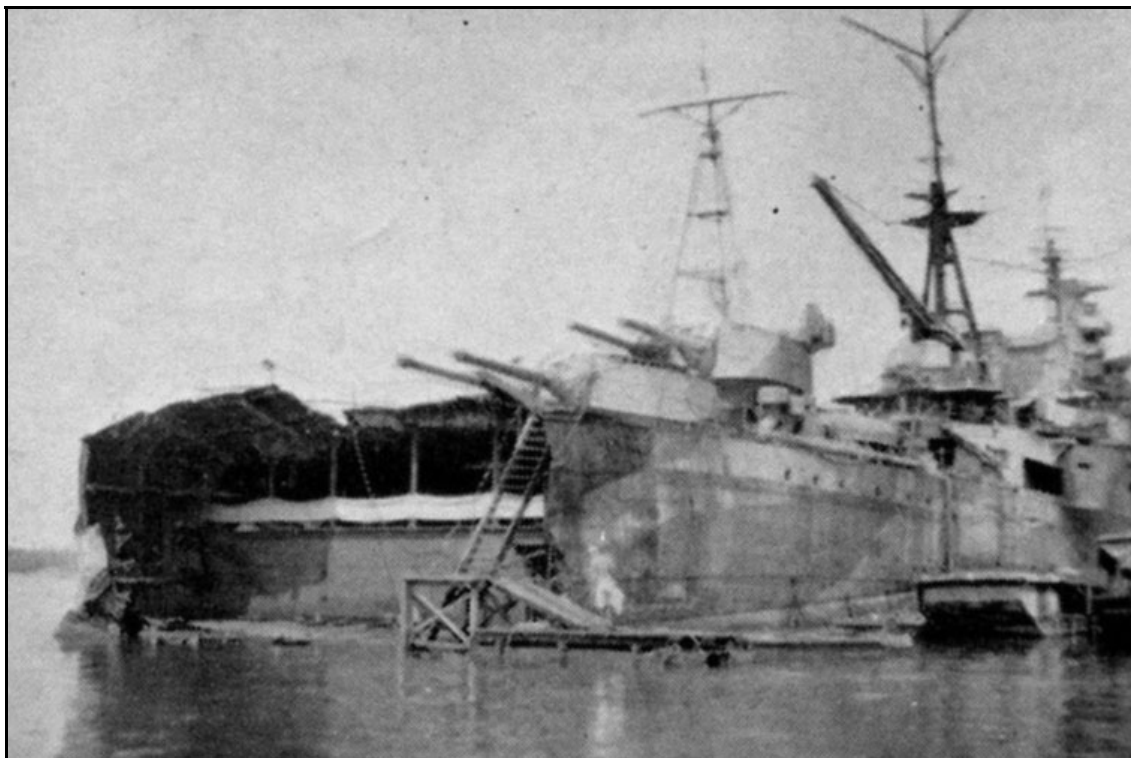
*HIJMS Myoko* in Singapore, circa 1945. Note how her stern has broken off just aft of where *Haguro* has split across her Quarterdeck. Note also that *Myoko's* interior appears to be 'shored up' at about the same location as can be seen when looking forward into the break in *Haguro*, i.e. the photo on left, page 28.
